EASTSIDE RAIL CORRIDOR REGIONAL TRAIL MASTER PLAN PROJECT

2015-05-12

The Eastside Rail Corridor Regional Trail Master Plan Project develops a baseline inventory and planning guidelines for portions of the Eastside Rail Corridor owned by King County and Sound Transit.

Prepared by: Parametrix

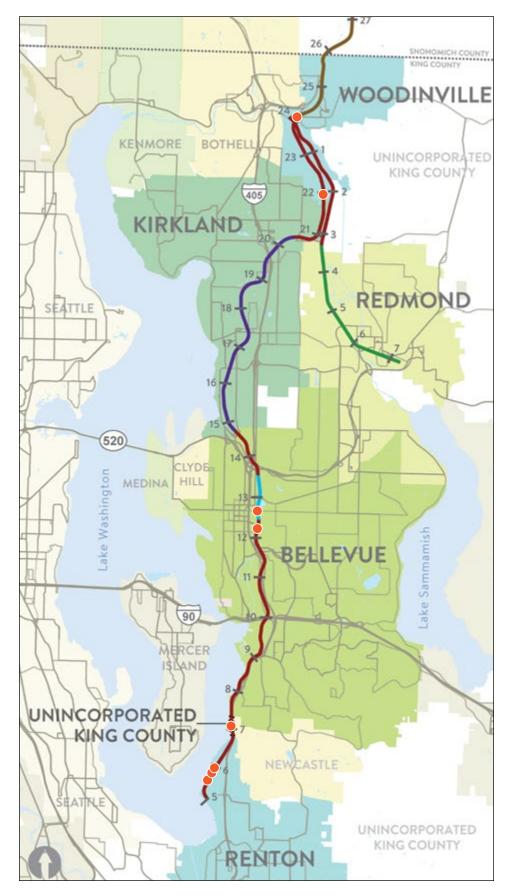
Figure 4 - ERC High Emphasis Crossings

Driveway 11A-Renton is located adjacent to Lake Washington Boulevard North between Burnett Avenue N and N 33rd Street in Renton. This crossing could require additional design considerations because of challenges related to slope, sight distance, and intersection geometrics.

The driveway that intersects with the trail corridor has a particularly steep grade of approximately 17 percent on the east approach and 10 percent on the west approach. This could create sight distance concerns between trail users and vehicles accessing the private driveway. The presence of vegetation on the west side of the corridor could also reduce sight distance for trail users traveling southbound.

The nearest intersection to this crossing is within approximately 15 to 20 feet, which would create unsafe conditions for vehicles if they were stopped while trail users cleared the crossing. Stopped vehicles at this crossing could impede free-flow traffic on Lake Washington Boulevard North and result in safety issues. However, it is likely that this crossing would experience low vehicle volumes.

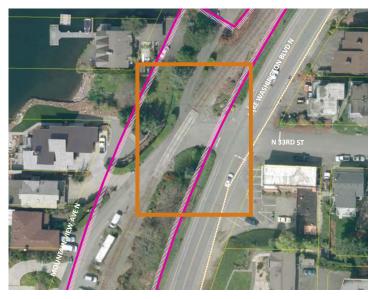
# MOUNTAIN VIEW AVENUE NORTH

- The crossing is located on a low volume, residential street.
- The northwest driveway could have limited sight distance of southbound trail users.
- There is use of the west right-of-way as parking.
- This is a high-emphasis crossing.

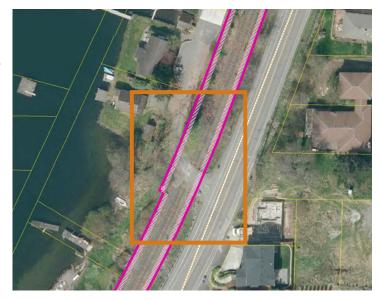
# **DRIVEWAY 11A - RENTON**

- The crossing is located on a private driveway with a narrow right-of-way due to grade on either side of corridor.
- The distance to the nearest intersection could create conflicts with queuing vehicles and traffic on Lake Washington Boulevard North.
- This is a high-emphasis crossing.

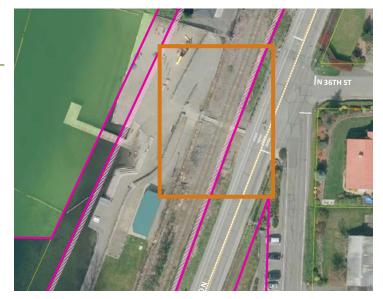
- The crossing is located on a pedestrian crossing that leads to Kennydale Beach Park.
- The right-of-way is narrow because of grading on either side of the corridor.

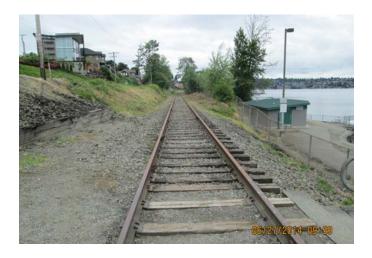
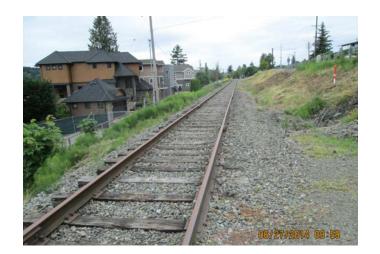
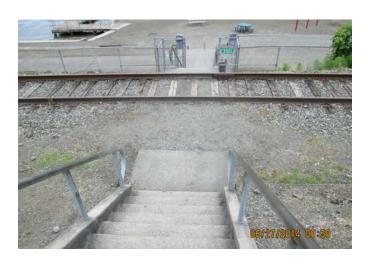
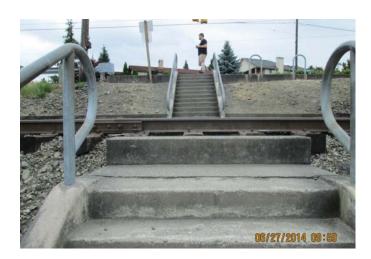
# PEDESTRIAN CROSSING 11 - RENTON

# **NORTH APPROACH**

**SOUTH APPROACH**

**EAST APPROACH**

**WEST APPROACH**

Advance warning signing

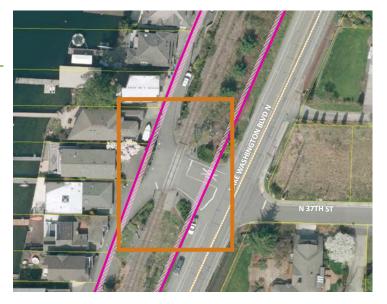
- The crossing is located on a residential street.
- There are three approaches to the crossing from the east, northwest, and southwest.
- · This is a high-emphasis crossing.

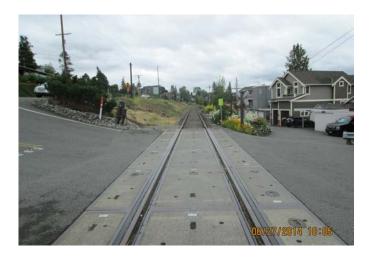
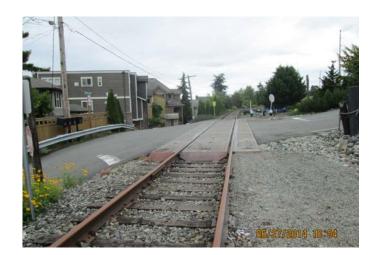
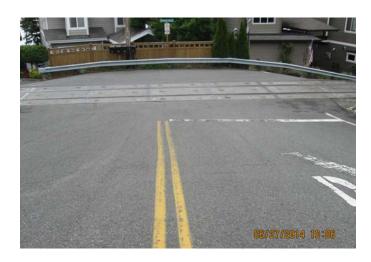
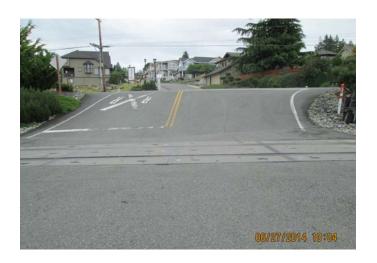
# **NORTH 37TH STREET**

# NORTH APPROACH

**SOUTH APPROACH**

**EAST APPROACH**

**WEST APPROACH**

- Roadway restriping
- Advance warning signing

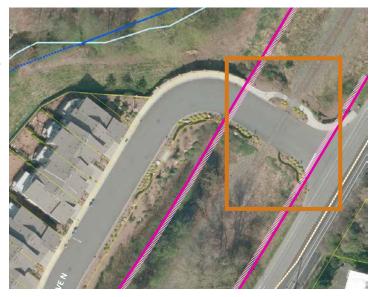
# **WELLS AVENUE NORTH**

- The crossing is located on a residential street.
- There is a sidewalk crossing over the north approach.

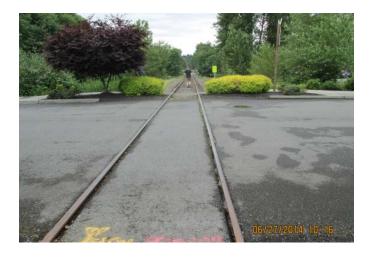
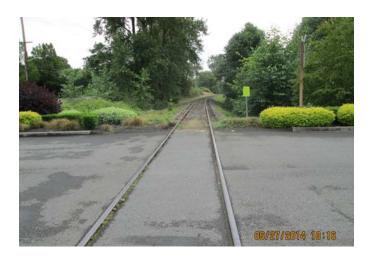
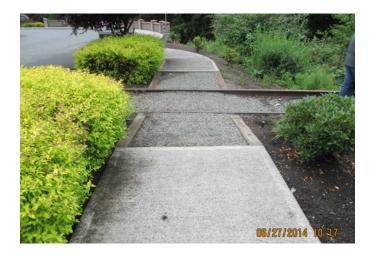
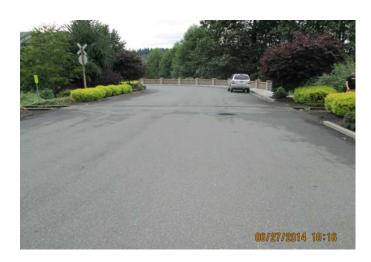
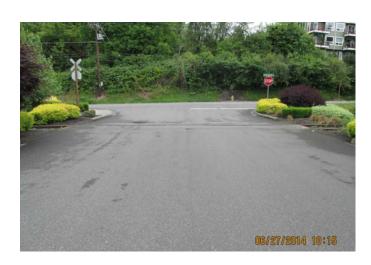
# NORTH APPROACH

**SOUTH APPROACH**

NORTH APPROACH SIDEWALK

**EAST APPROACH**

**WEST APPROACH**

- Roadway restriping
- Advance warning signing

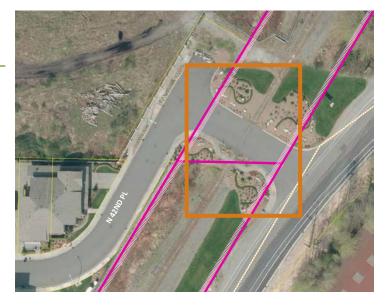
# **NORTH 42ND PLACE**

- The crossing is located on a residential street.
- There is a sidewalk crossing over the south approach.

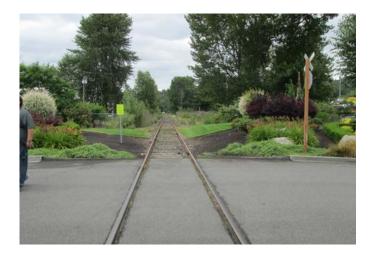
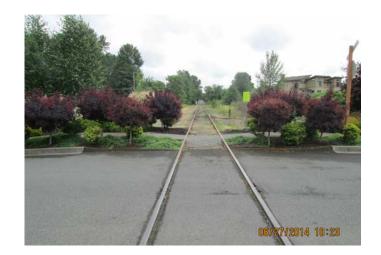
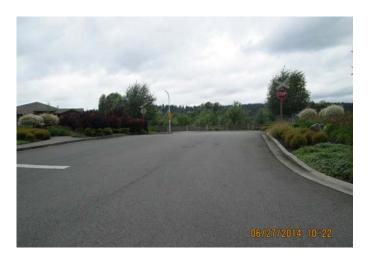
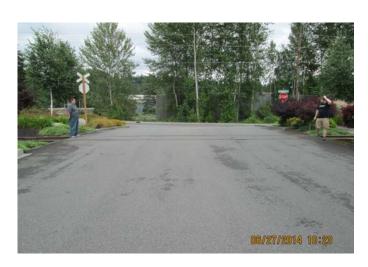
# NORTH APPROACH

**SOUTH APPROACH**

**EAST APPROACH**

**WEST APPROACH**

- Roadway restriping
- Advance warning signing

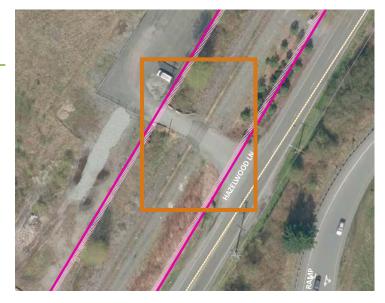
# **DRIVEWAY 16A - RENTON**

• The crossing is located on a private driveway.

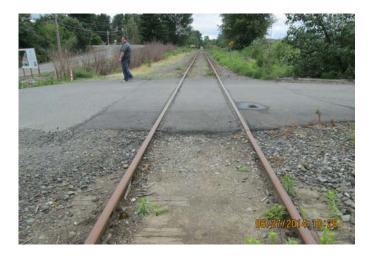
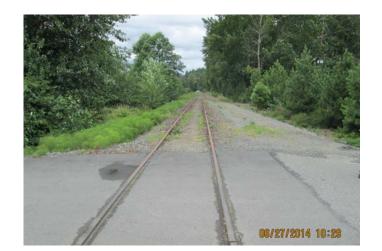
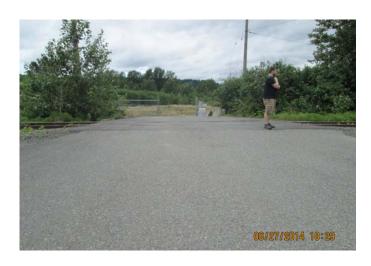
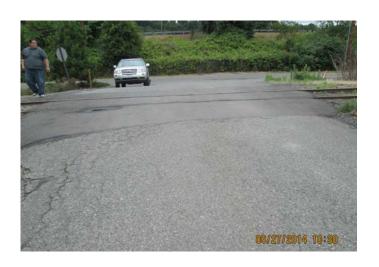
**SOUTH APPROACH**

**EAST APPROACH**

**WEST APPROACH**

- Roadway restriping
- Advance warning signing

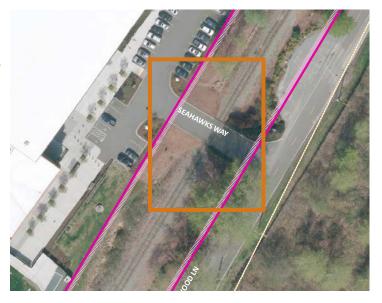
# **DRIVEWAY 17A - RENTON**

• The crossing is located on a private driveway.

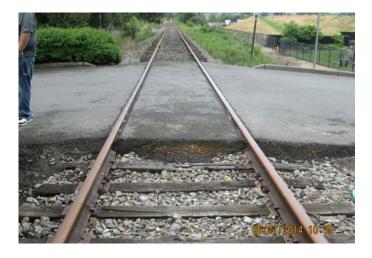
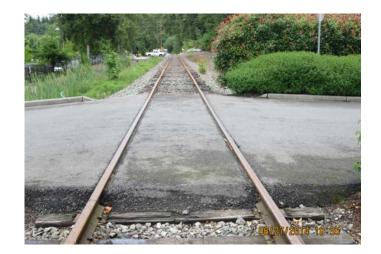
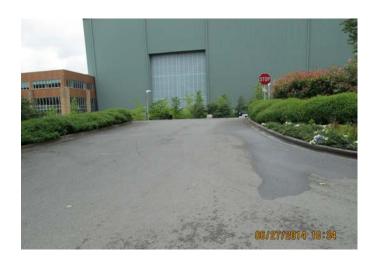
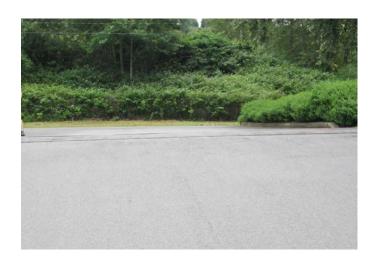
**SOUTH APPROACH**

**EAST APPROACH**

**WEST APPROACH**

- Roadway restriping
- Advance warning signing

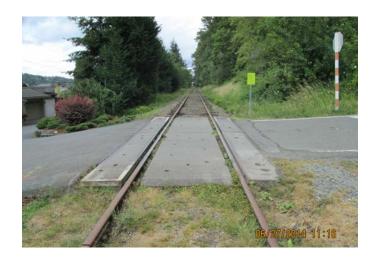
PARKING IN SOUTHEAST RIGHT-OF-WAY

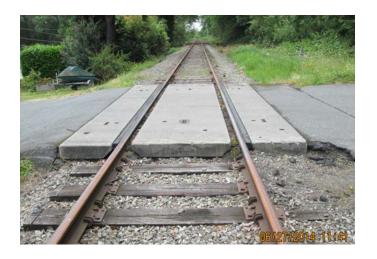
PARKING IN NORTHWEST RIGHT-OF-WAY

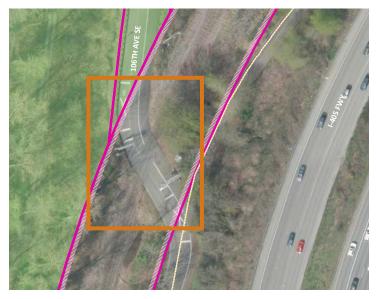
- The crossing is located on an arterial.
- The crossing provides access to Newcastle Beach Park.
- The posted speed limit is 25 MPH.
- The geometrics of the roadway of the west approach could create sight distance issues.
- This is a high-emphasis crossing.

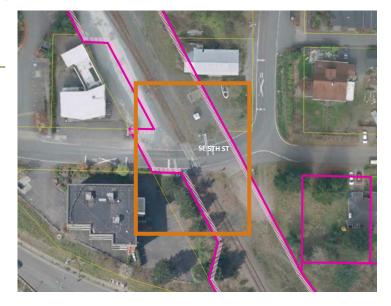
# SE 5TH STREET

- The crossing is located on a minor arterial.
- The posted speed is 25 MPH.
- The right-of-way is used for parking.

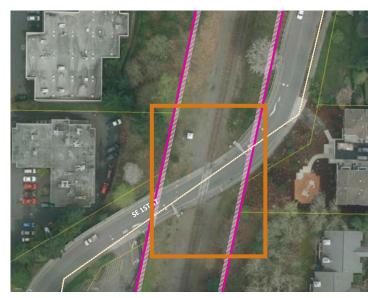
- The crossing is located on an arterial with higher traffic volumes.
- The posted speed is 25 MPH; vehicles traveling westbound down the hill drive fast.
- There are sidewalk crossings over the north and south approach.
- This is a high-emphasis crossing.

**OTHER:** Sidewalk crossings over north and south approaches. Westbound vehicles were observed to

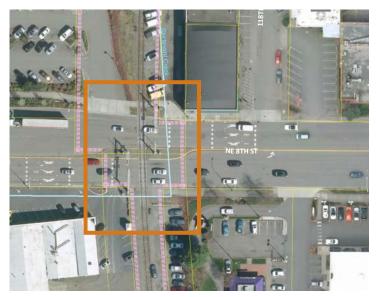
# **NE 8TH STREET**

- The crossing is located on an arterial with high traffic volumes.
- The posted speed is 30 MPH.
- There are sidewalk crossings over the north and south approaches.
- There is a bus stop at the near-east approach.
- There is parking in the right-of-way and numerous driveways near the crossing.
- Queuing at nearby intersections blocks the crossing.
- · This is a high-emphasis crossing.

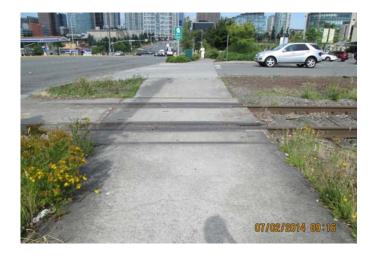
## **EAST APPROACH**

W approach: 90°; E approach: 90°

ESTIMATED SLOPE: E/W approach: 2-3% CROSSING CONTROL TYPE: None

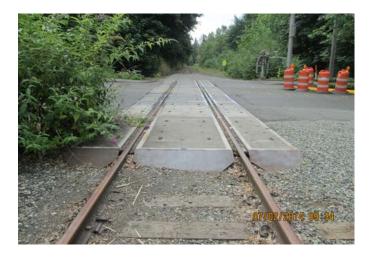
**SOUTH APPROACH**

- · The crossing is located on an arterial.
- The posted speed is 25 MPH.
- There are sidewalk crossings over the north and south approaches.
- There is a bus stop near the east approach.

- Revise traffic speeds/traffic calming
- Roadway restriping
- Remove or relocate visual obstructions
- Advance warning signing

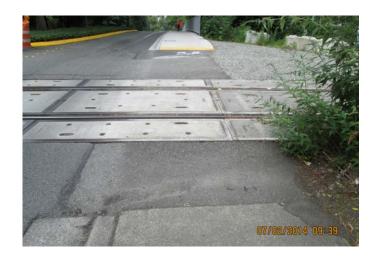
# **EAST APPROACH**

**ESTIMATED SLOPE:** E approach: 3%;

Hill on west approach; curve before east approach

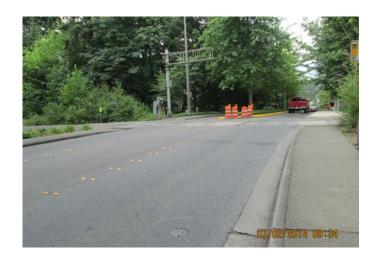
**WEST APPROACH**

W approach: 1%

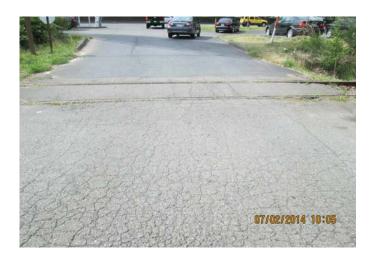
**SOUTH APPROACH**

- The crossing is located on a private driveway.
- There are driveways and parking nearby.

- Roadway restriping
- Stop control/intersection priority
- Advance warning signing

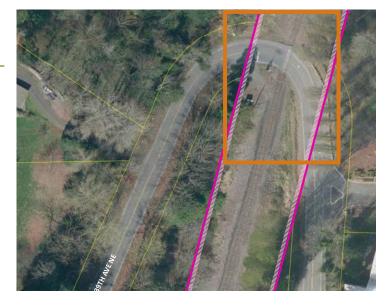
# 139TH AVENUE NE

- The crossing is located on an arterial.
- The roadway makes a 180° turn through intersection.
- The grade of east right-of-way is steep.
- This is a high-emphasis crossing.

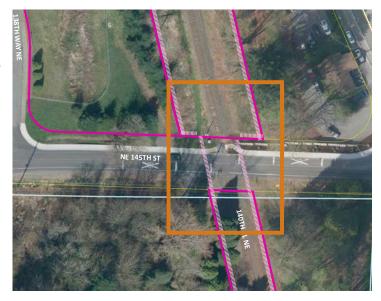
# **NE 145TH STREET**

- The crossing is located on an arterial.
- The roadway grade on either side of crossing is steep.

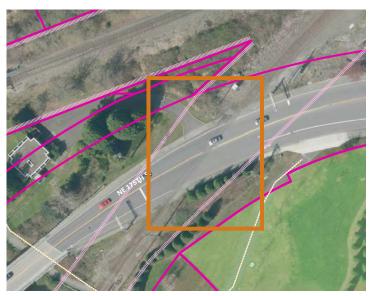
# **NE 175TH STREET**

- · The crossing is located on an arterial.
- The posted speed limit is 35 MPH.
- · There is a wide crossing width.
- Potential sight distance issues on east approach.
- On the nearby vehicle overpass west of the crossing, railing could create sight distance issues for northbound trail users.
- This is a high-emphasis crossing.

Angle of the east approach could cause sight distance issues

eastbound on NE 175th Street. This road also accommodates a higher traffic volume, which could require additional design considerations to ensure safe crossings.

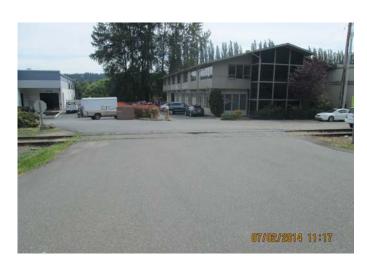
**WEST APPROACH**

Trees and shrubs in west right-of-way

Overhead power in west and south right-of-way

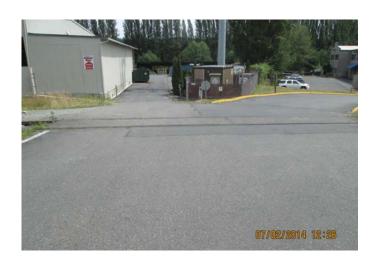
**WEST APPROACH**

**OTHER:** Possible wetlands in west right-of-way

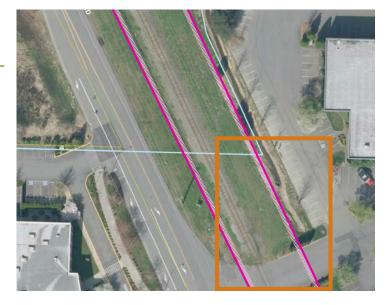
# **DRIVEWAY 16B - WOODINVILLE**

- The crossing is located on a private driveway.
- The right-of-way is narrow in this part of the corridor.

**TYPE:** Private driveway **LANES:** 1 lane east/west

**CROSSING WIDTH:** About 55 feet

**ESTIMATED SLOPE:** E approach: 3%;

CROSSING CONTROL TYPE: Stop controlled NEAREST INTERSECTION DISTANCE/CONTROL TYPE: About 60 feet; 1-way stop

Overhead power in north right-of-way

Narrow right-of-way

- Revise traffic speeds/traffic calming
- Advance warning signing
- Location of crossing within corridor ownership
- Signal timing modification at existing signal

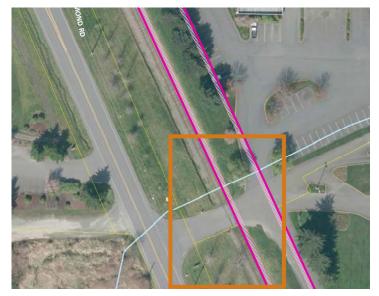
# **DRIVEWAY 17A - WOODINVILLE**

- The crossing is located on a private driveway.
- The right-of-way is narrow in this part of the corridor.

**TYPE:** Private driveway

CROSSING WIDTH: About 30 feet

**ESTIMATED SLOPE:** E approach: 4%;

**CROSSING CONTROL TYPE:** Stop controlled

Gas line

Narrow right-of-way

- Roadway restriping
- Advance warning signing

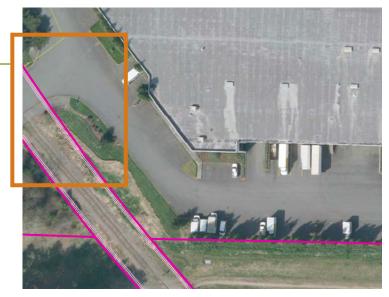
# DRIVEWAY 19A - WOODINVILLE

- The crossing is located on a private driveway.
- The right-of-way is narrow in this part of the corridor.

LANES: One lane eastbound, two lanes westbound

CROSSING WIDTH: About 40 feet

**ESTIMATED SLOPE:** E approach: 4%;

- Roadway restriping
- Advance warning signing

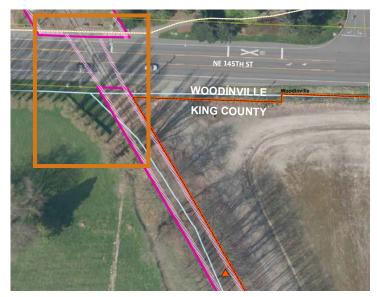
# **NE 145TH STREET**

- The crossing is located on an arterial with heavier traffic volumes.
- There are several nearby driveways.

**TYPE:** Arterial street

- Revise traffic speeds/traffic calming
- Roadway restriping
- Advance warning signing
